UNITED STATES ENVIRONMENTAL PROTECTION AGENCY

SUBJECT: Certain-Teed Transite Pipe Plant, St. Louis, Missouri
(SBR 59)

At the request of the Air and Toxics Division (ARTX), the Environmental Monitoring and Compliance Branch (EMCM), Air Monitoring Section conducted an inspection at the old Certain-Teed transite pipe manufacturing facility in St. Louis, Missouri. The purpose of the inspection was to determine the amount and condition of exposed asbestos containing transite pipe, buried and abandon on the property.

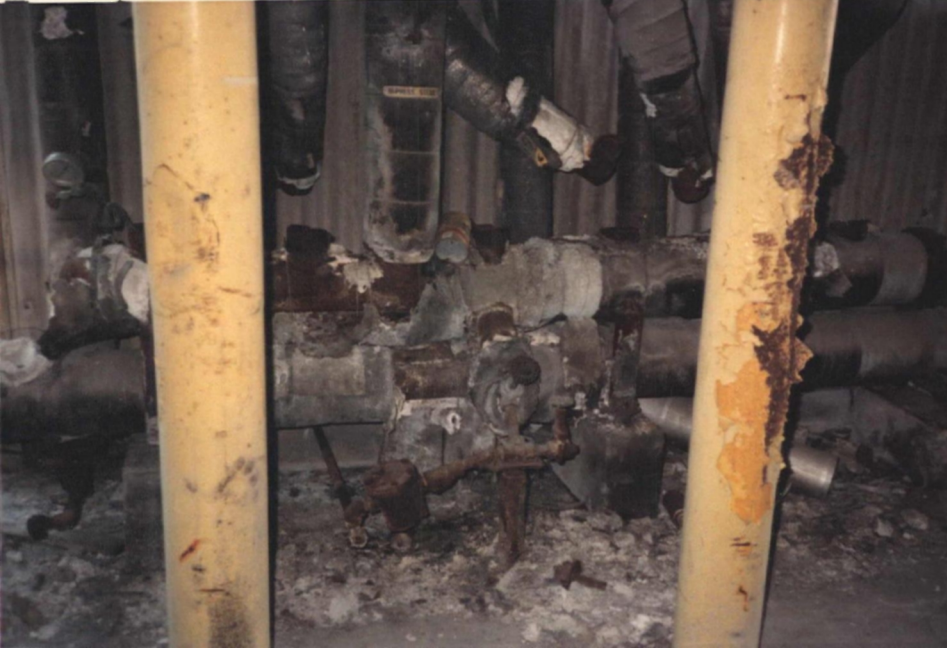
7

DETERIORATING PIPE INSULATION IN BUILDING

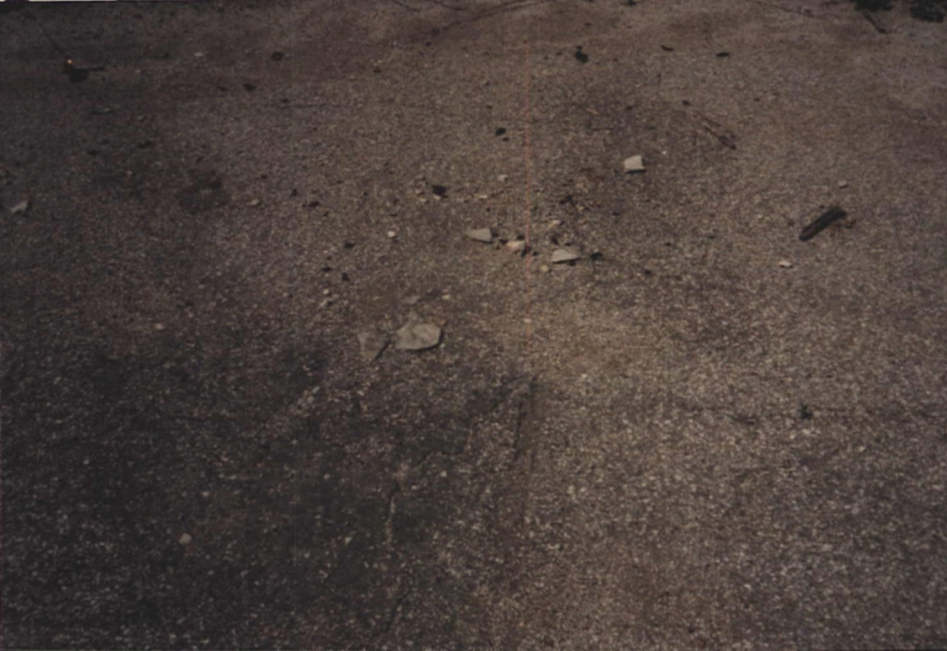
8

PIECES OF TRANSIT ON WEST PARKING LOT

SAMPLE SITE SBR59-003

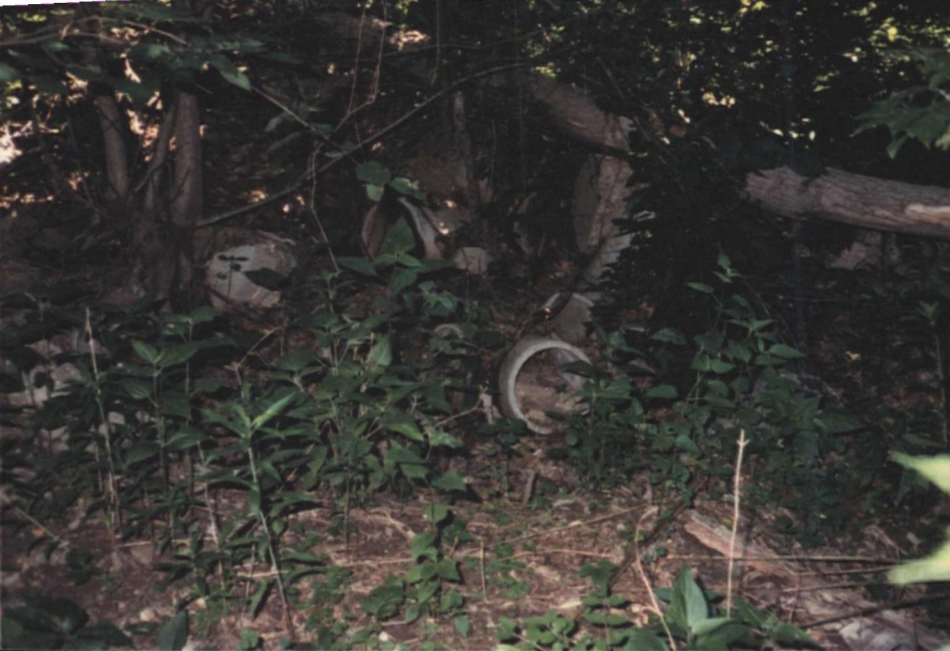
9

TRANSTIE PIPE ALONG WEST SIDE OF PLANT

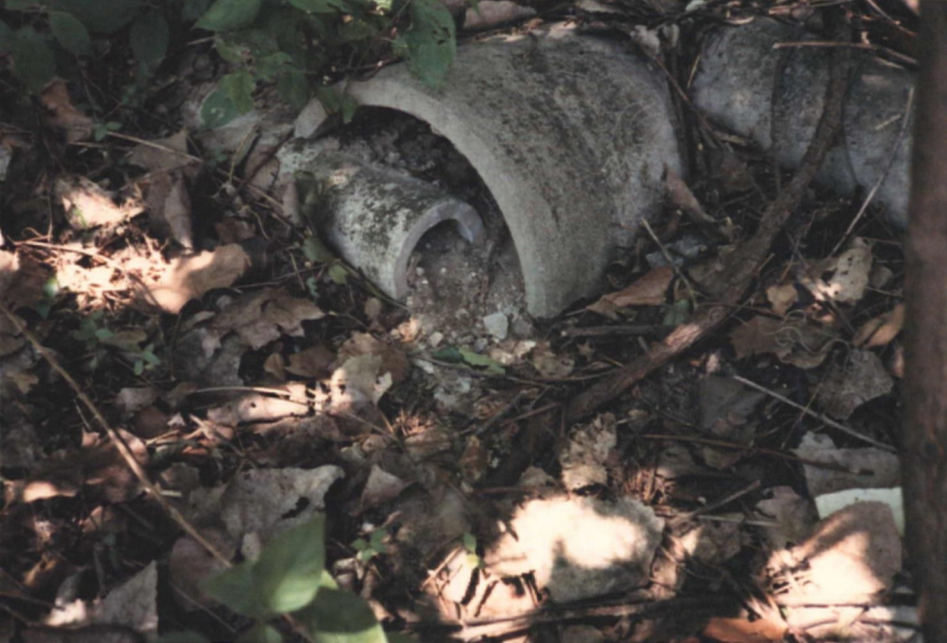
1

SAMPLE SITE SBR59-001, GRAY GRANULAR MATERIAL INSIDE
PIPE

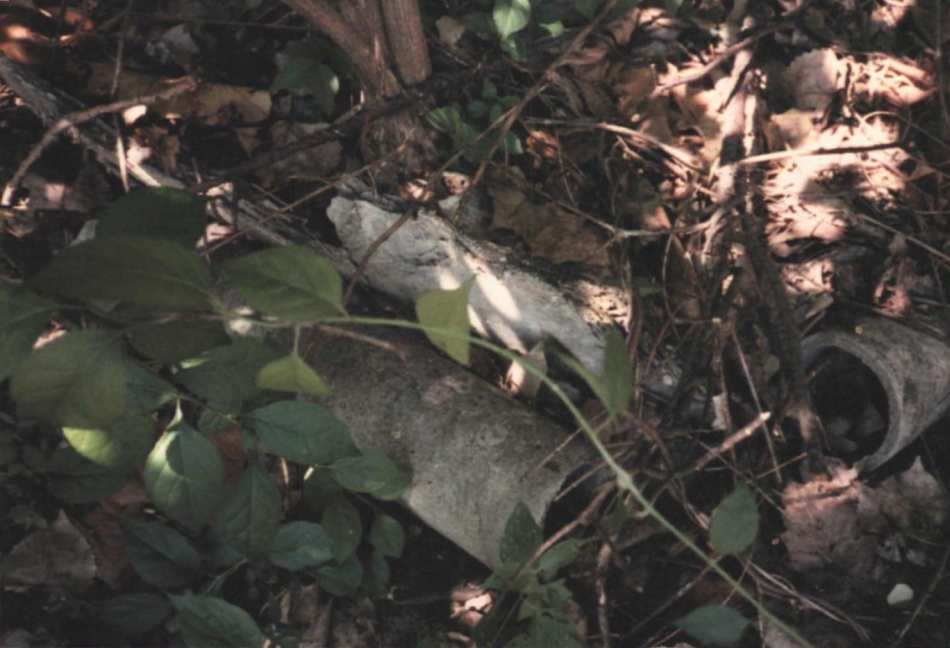
2

SAMPLE SITE SBR59-002, BROKEN TRANSITE PIPE

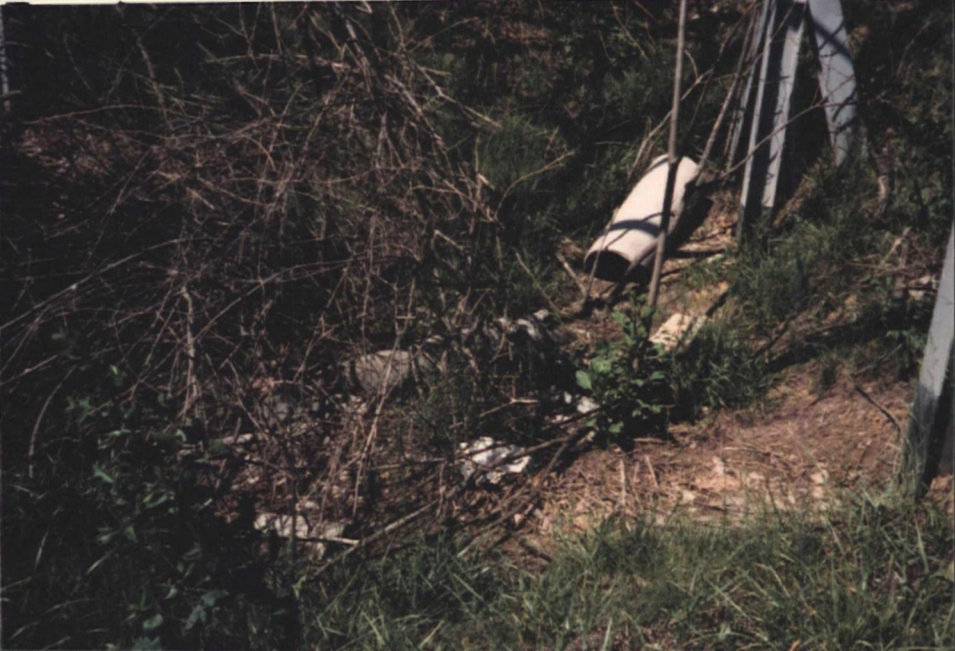
3

TRANSITE PIPE

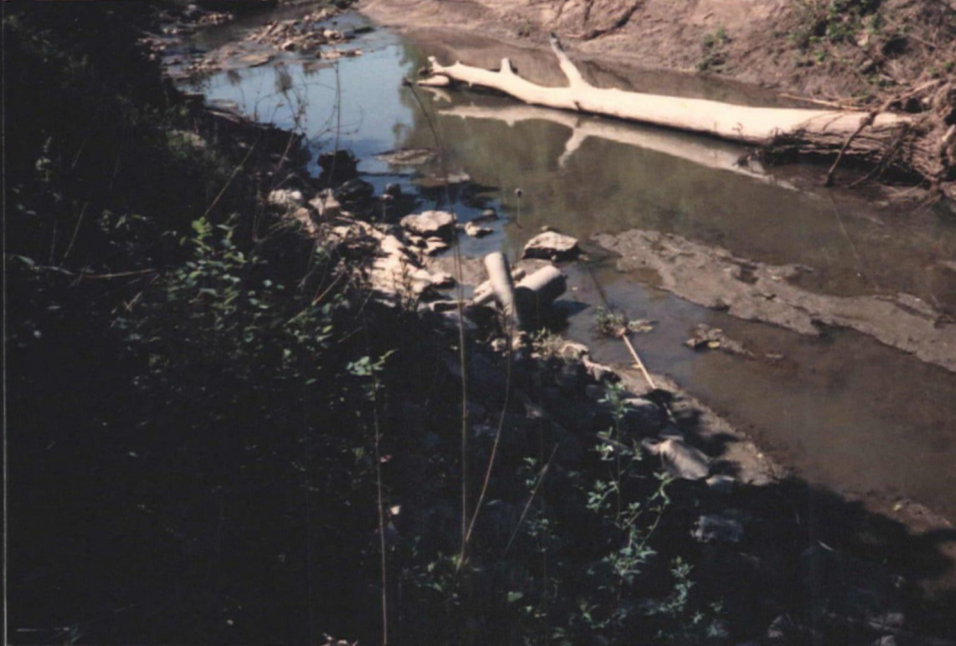
4

During the inspection, the waste pile area was covered with dirt and grass, and appeared to be stable. A small amount of pipe was visible on the north side by a drainage ditch. See the attached photographs (Attachment 2). Along the Maline Creek, the rock and bank has eroded and exposed transite pipe. Pipe was also in the river bed. If the river was higher, this material would be under water and not visible.

TRANSTIE PIPE IN MALINE CREEK

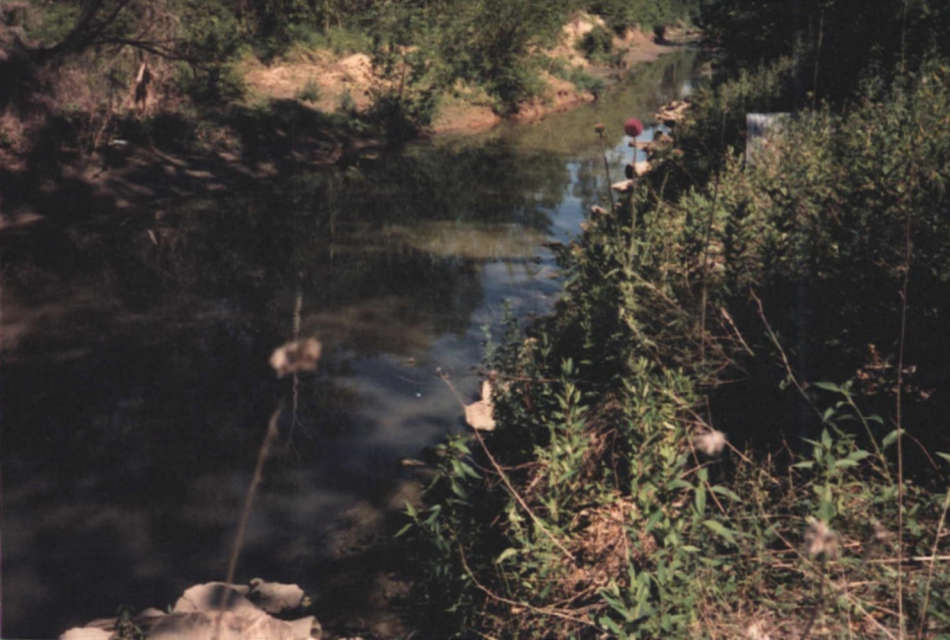
5

TRANSITE PIPE IN MALINE CREEK

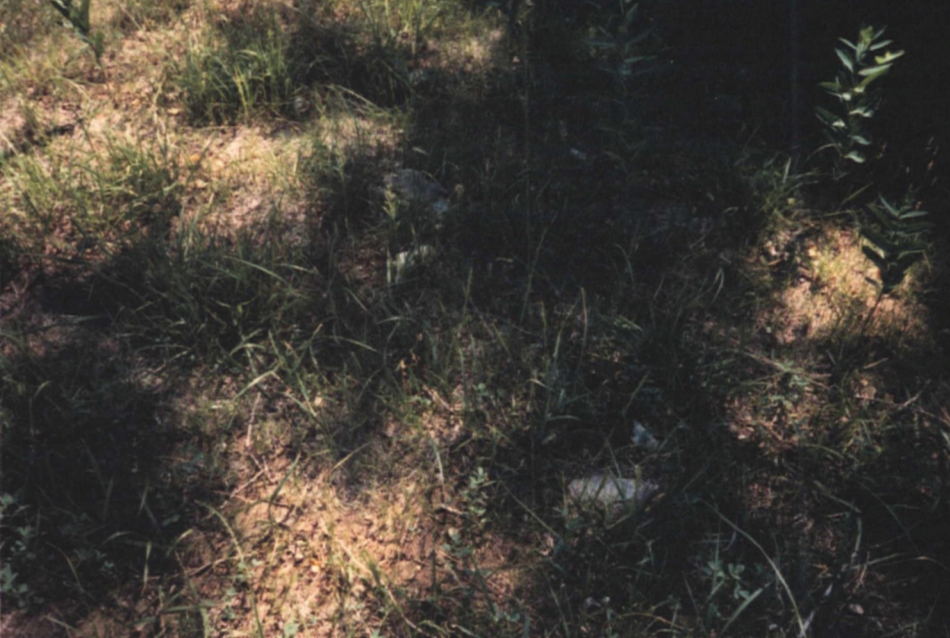
6

NORTH SIDE OF WASTE DUMP AREA TRANSITE PIECES VISIBLE

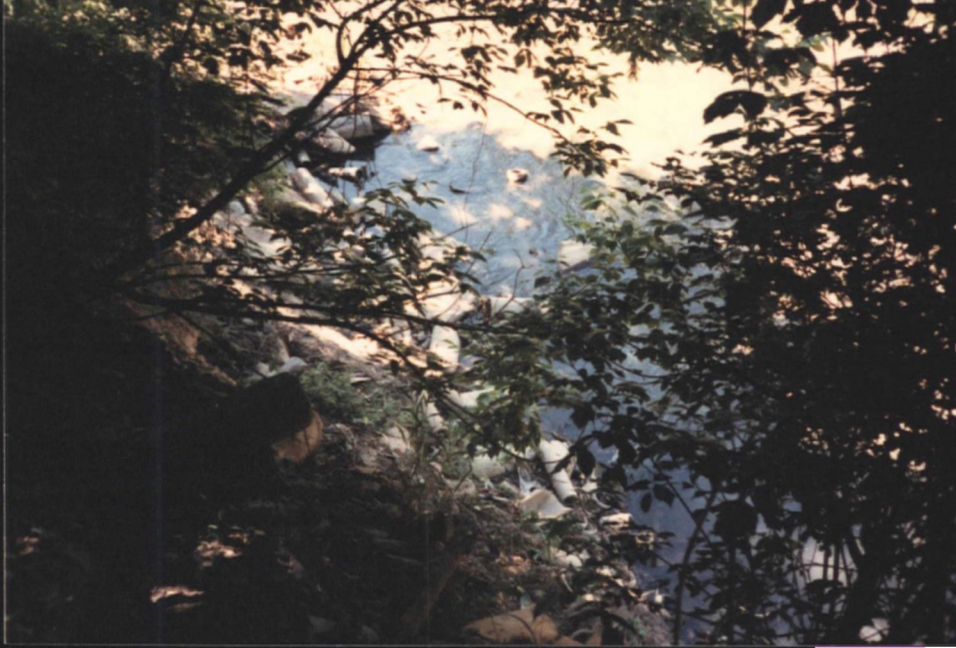
10

TRANSITE PIPE ALONG WEST SIDE OF PLANT IN MALINE CREEK

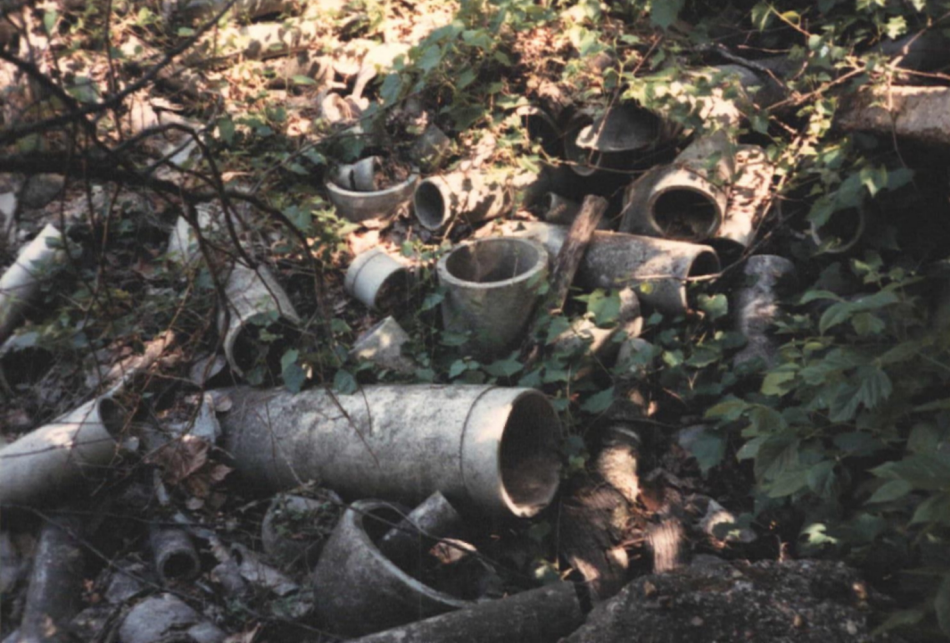
11

TRANSITE PIPE ALONG WEST SIDE OF PLANT

SAMPLE SITE SBR59-004

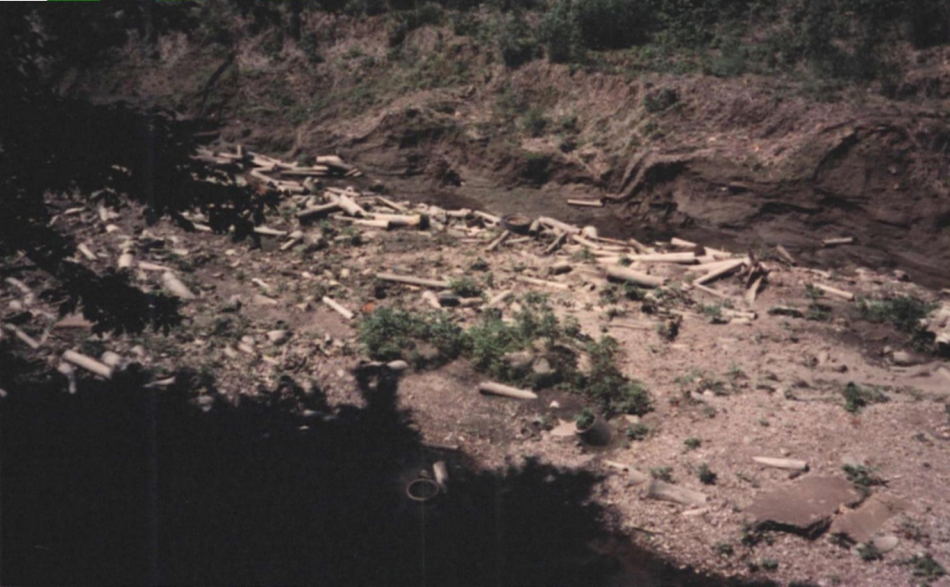
12

TRANSTIE PIPE ALONG WEST SIDE OF PLANT IN MALINE CREEK

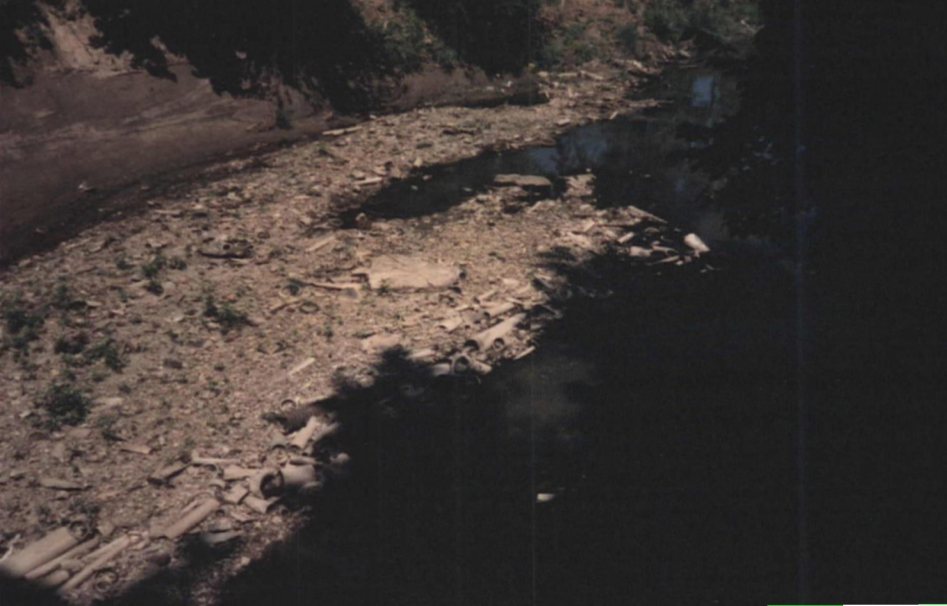
13

TRANSTIE PIPE ALONG WEST SIDE OF PLANT IN MALINE CREEK

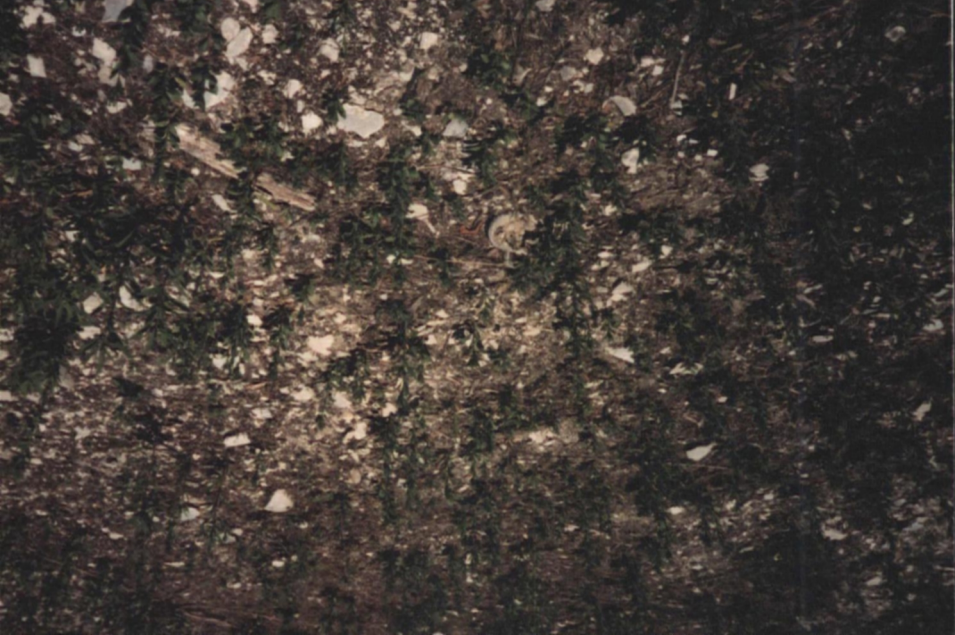
14

PIECES OF TRANSTIE ON WEST SIDE OF WEST PARKING LOT

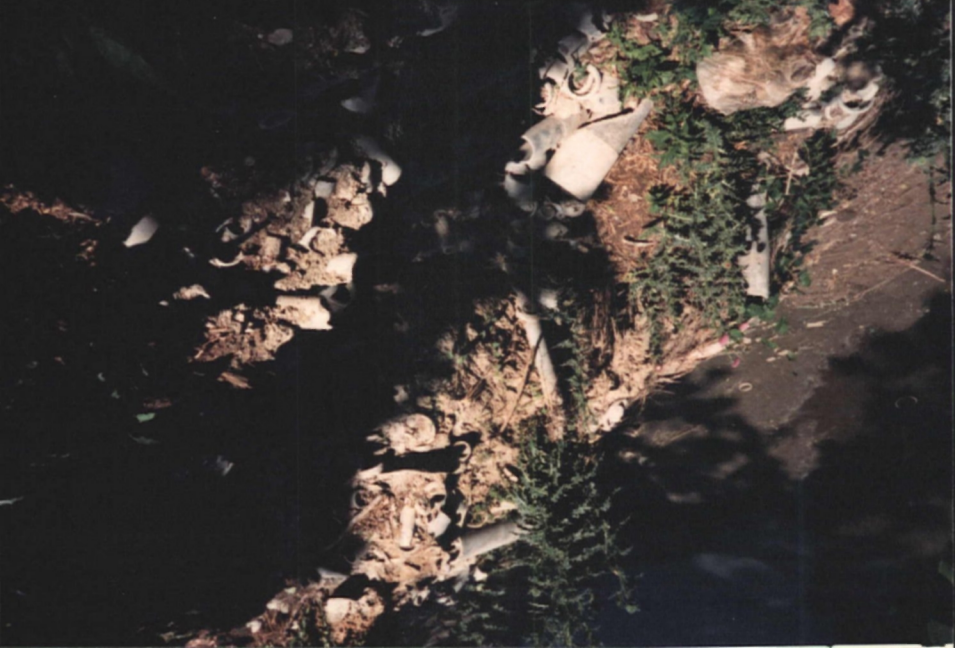
15

TRANSITE PIPE ALONG WEST SIDE OF PLANT ON MALINE CREEK
BANK

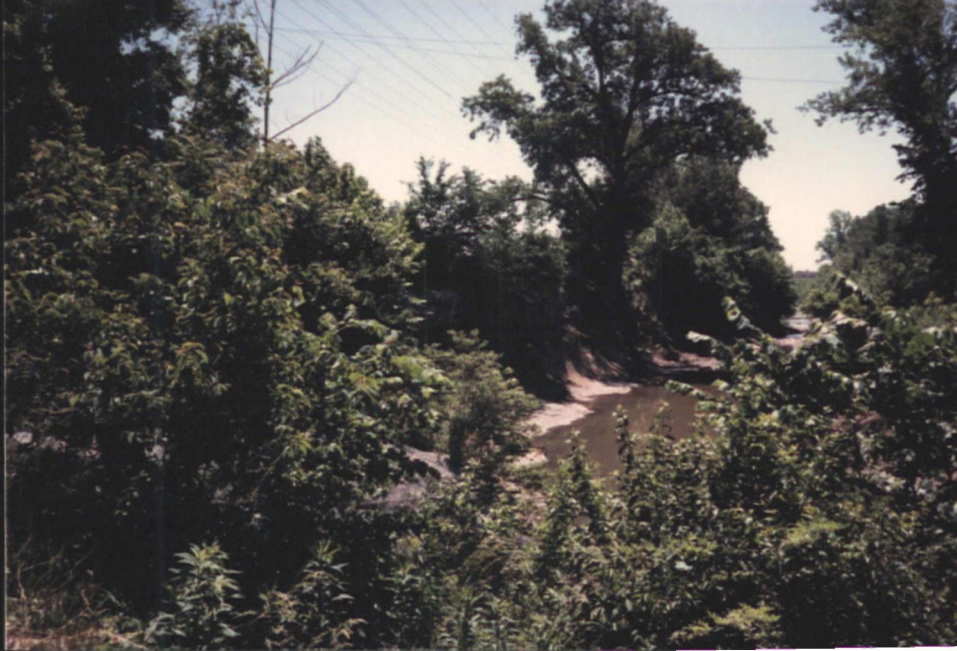
16

MALINE CREEK-TRANSITE PIPE IN CENTER OF PHOTO

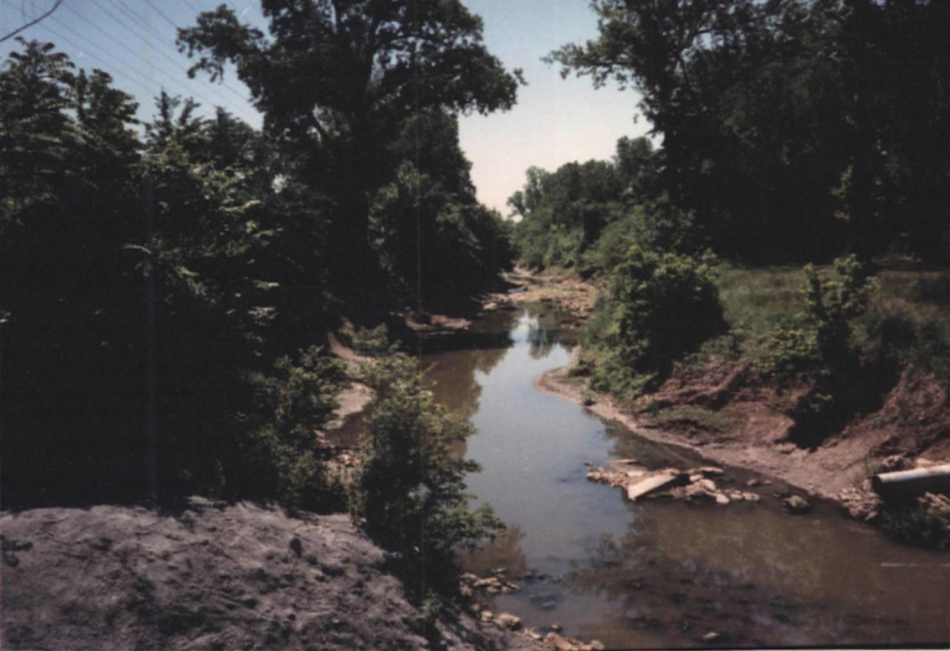
17

MALINE CREEK
